# Elements

## #0190 Troubleshooting

### #0190 Fine dust filter for intermediate acrylic.

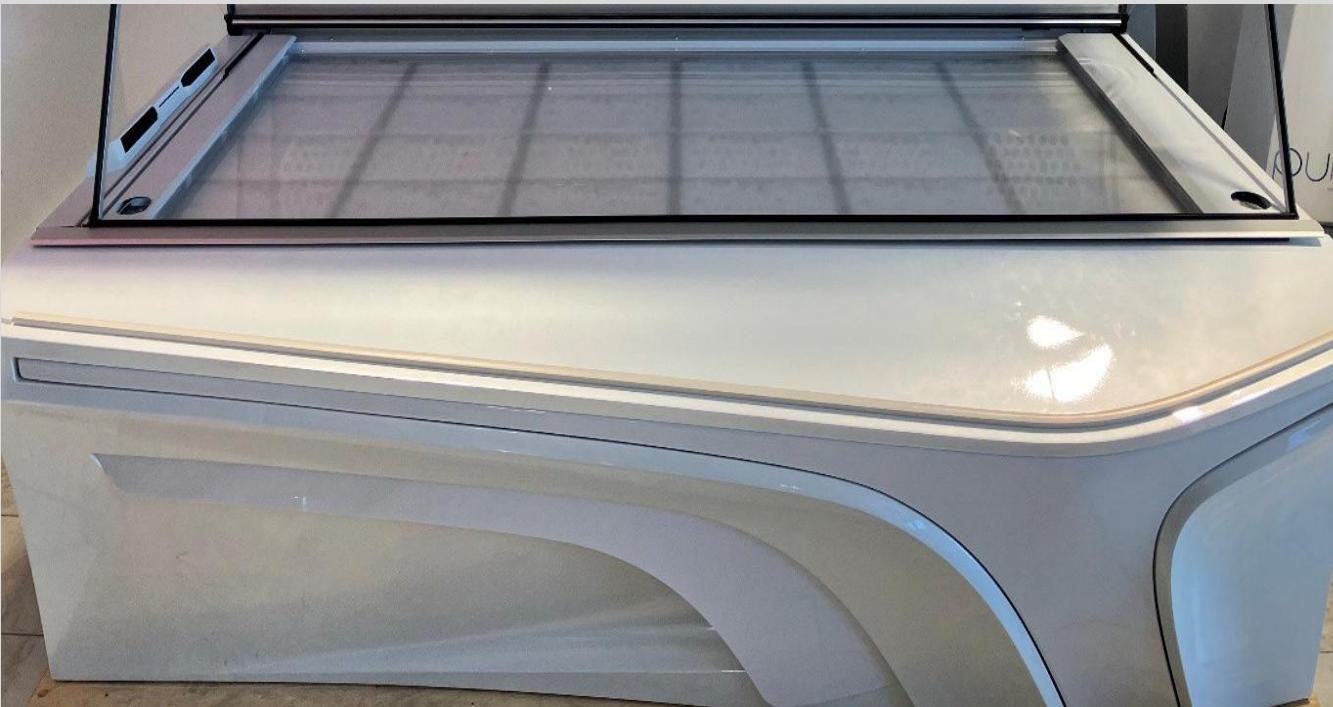
- The Elements has a sealed intermediate acrylic to prevent any dust or debris for entering the base UV LED area.
- This prevents debris or dust from touching the UV LEDs and causing damage.
- The cooled airflow over this area is now highly filtered.

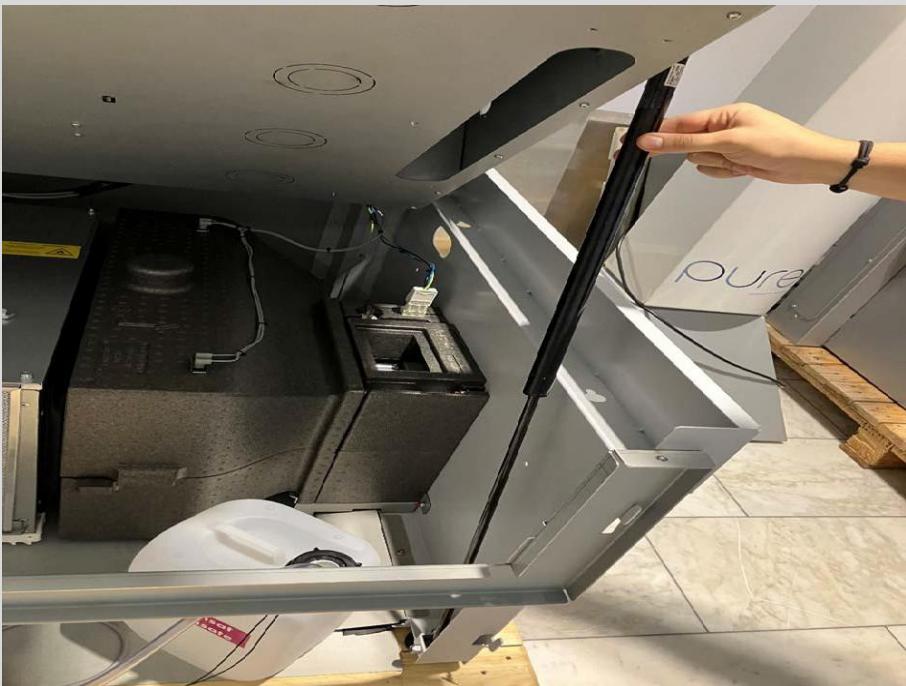
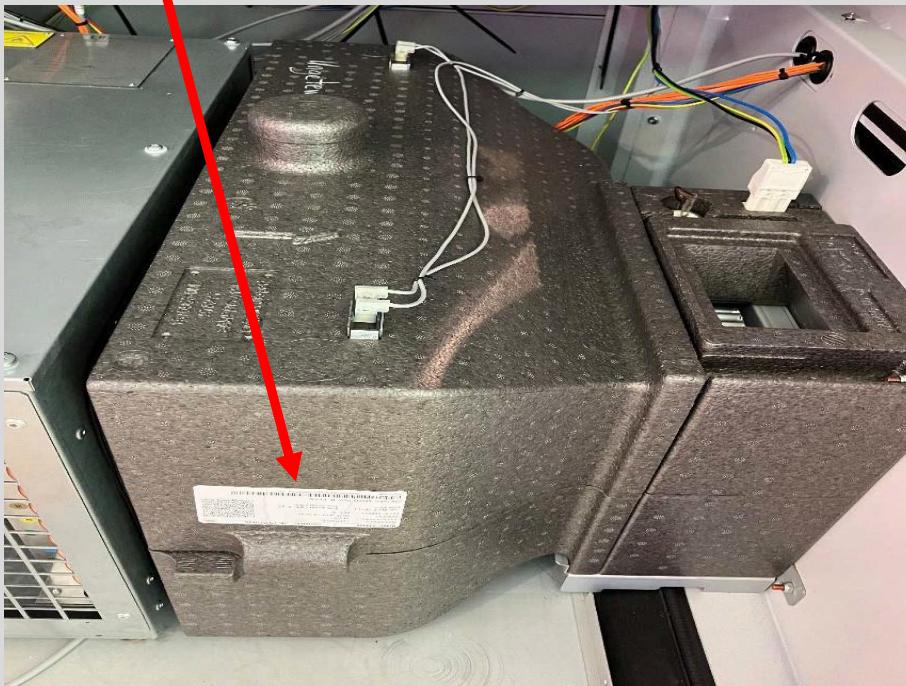
- These instructions may not be included in early versions of the Operating Instructions 1033787-00.
- Time to replace the filter. PN 1516988-00
- The filter is located to the right of the AC unit in the base.

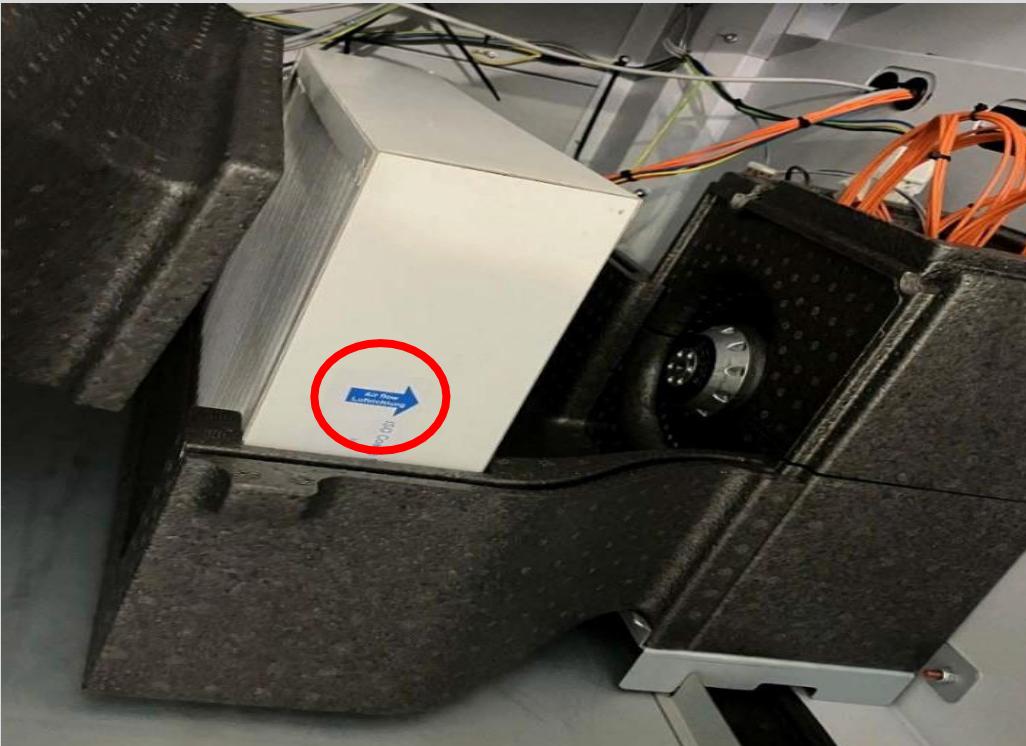
- Lift the lid off and remove the old filter. (No fasters to release)
- The airflow arrow must point away from the AC unit.

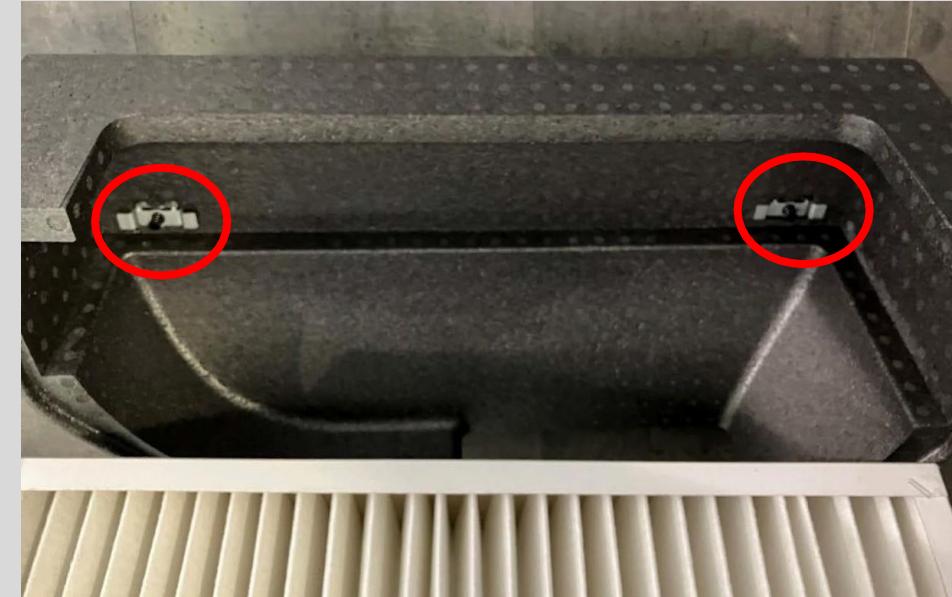
- Switches from under the lid.

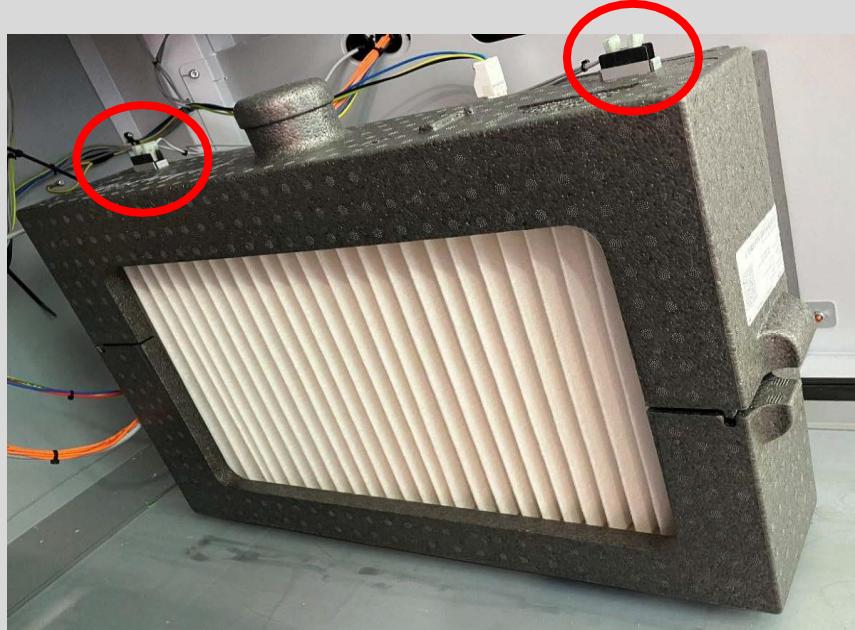
- There are 2 safety switches to ensure the filter is installed correctly.

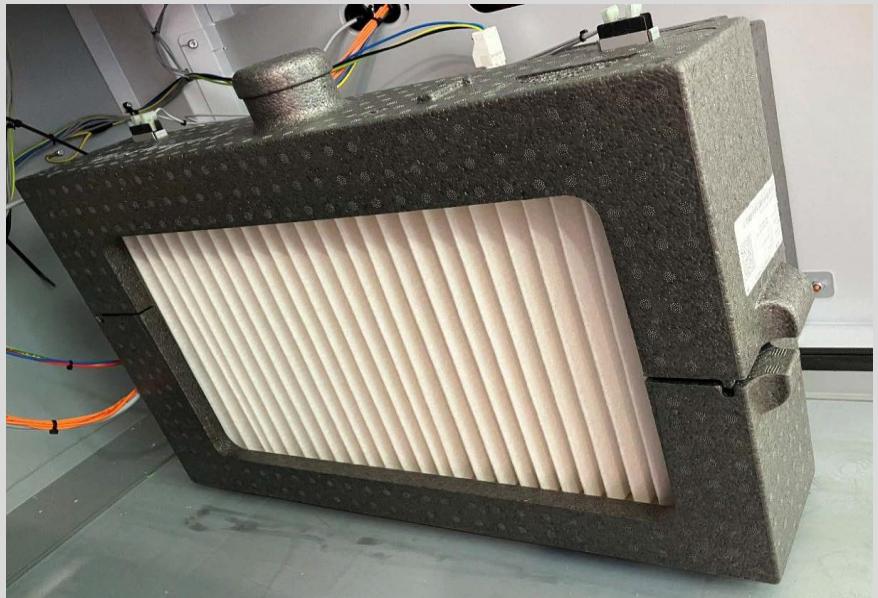
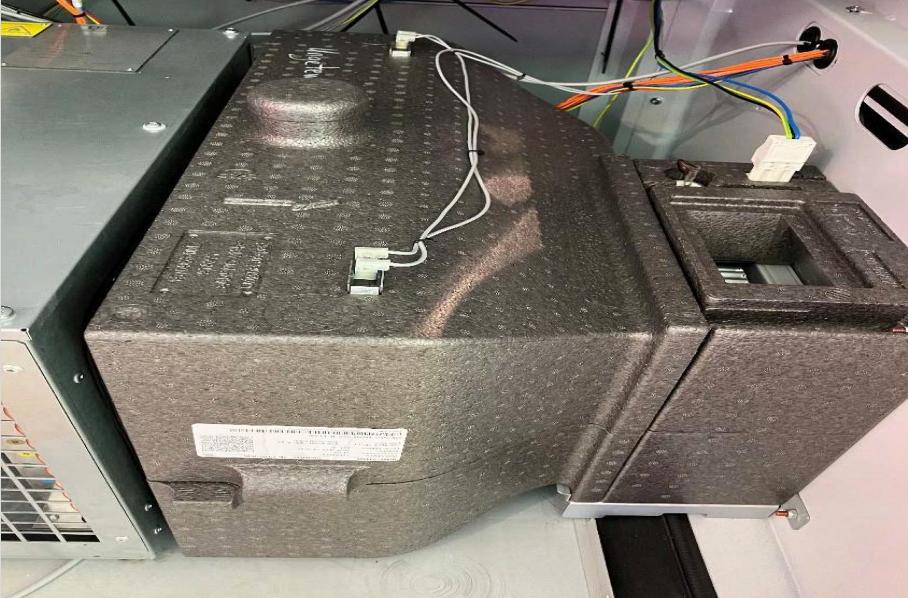
- Reassemble the filter lid.
- Close the bed.
- Access the PSM Hours of Operation.
- Reset the hours to zero.
- The error will clear.
